EMERGENCY AWARENESS BULLETIN

EAB-06006 Kentucky Fatal No. 5 (Nationally # 26) Machinery

COAL CO
FILE NUMBER - XXXX
HUFF CREEK MINE NUMBER 1
FATAL ACCIDENT

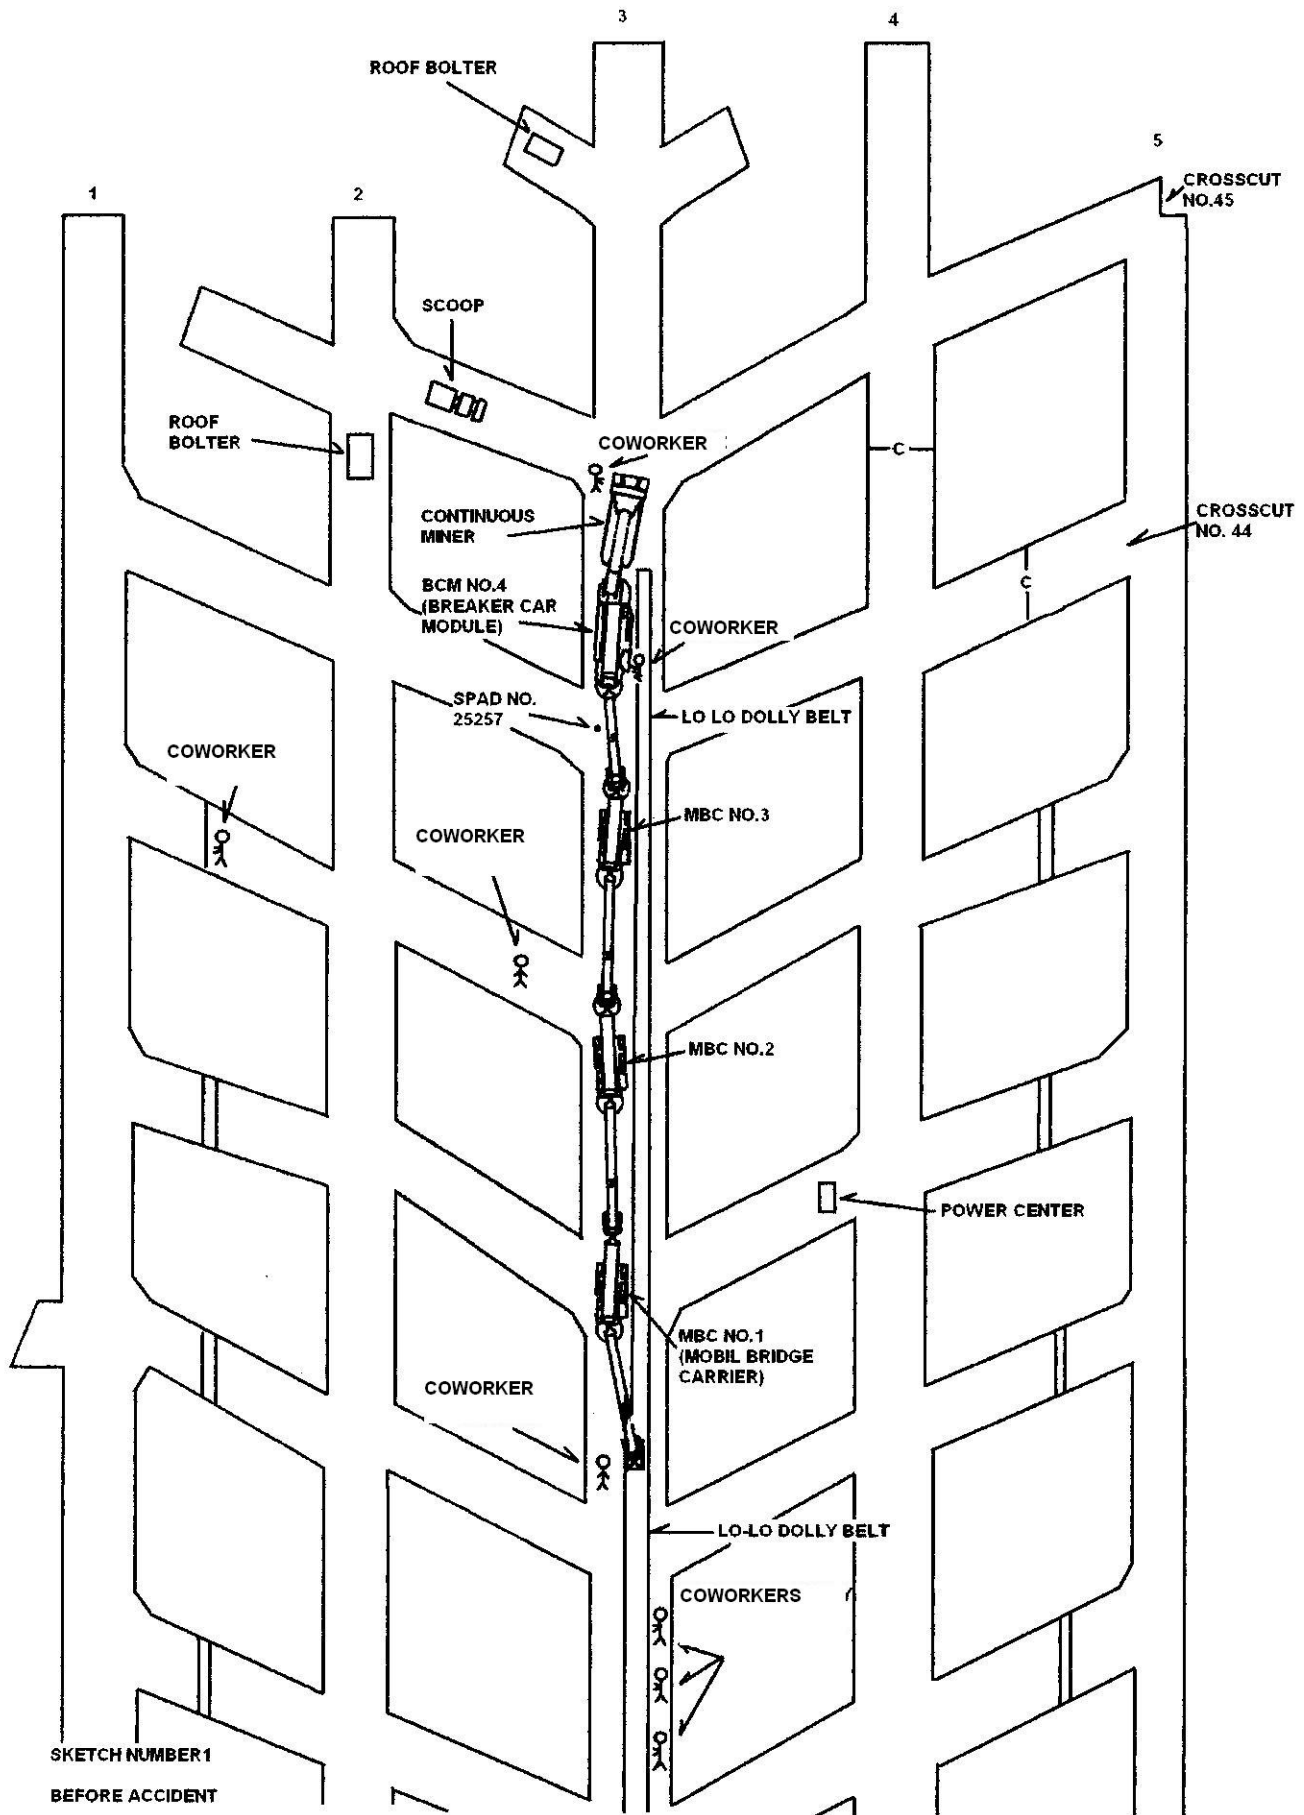
SKETCH NUMBER 1

EMPLOYEES POSITION PRIOR TO ACCIDENT

ENTRY WIDTH WAS 20 FEET

HEIGHT AT THE ACCIDENT SCENE
WAS 8 FEET AND 11 INCHES

17 INCHES OF CLEARANCE BETWEEN THE
LO-LO DOLLY BELT STRUCTURE AND THE
BREAKER CAR FRAME

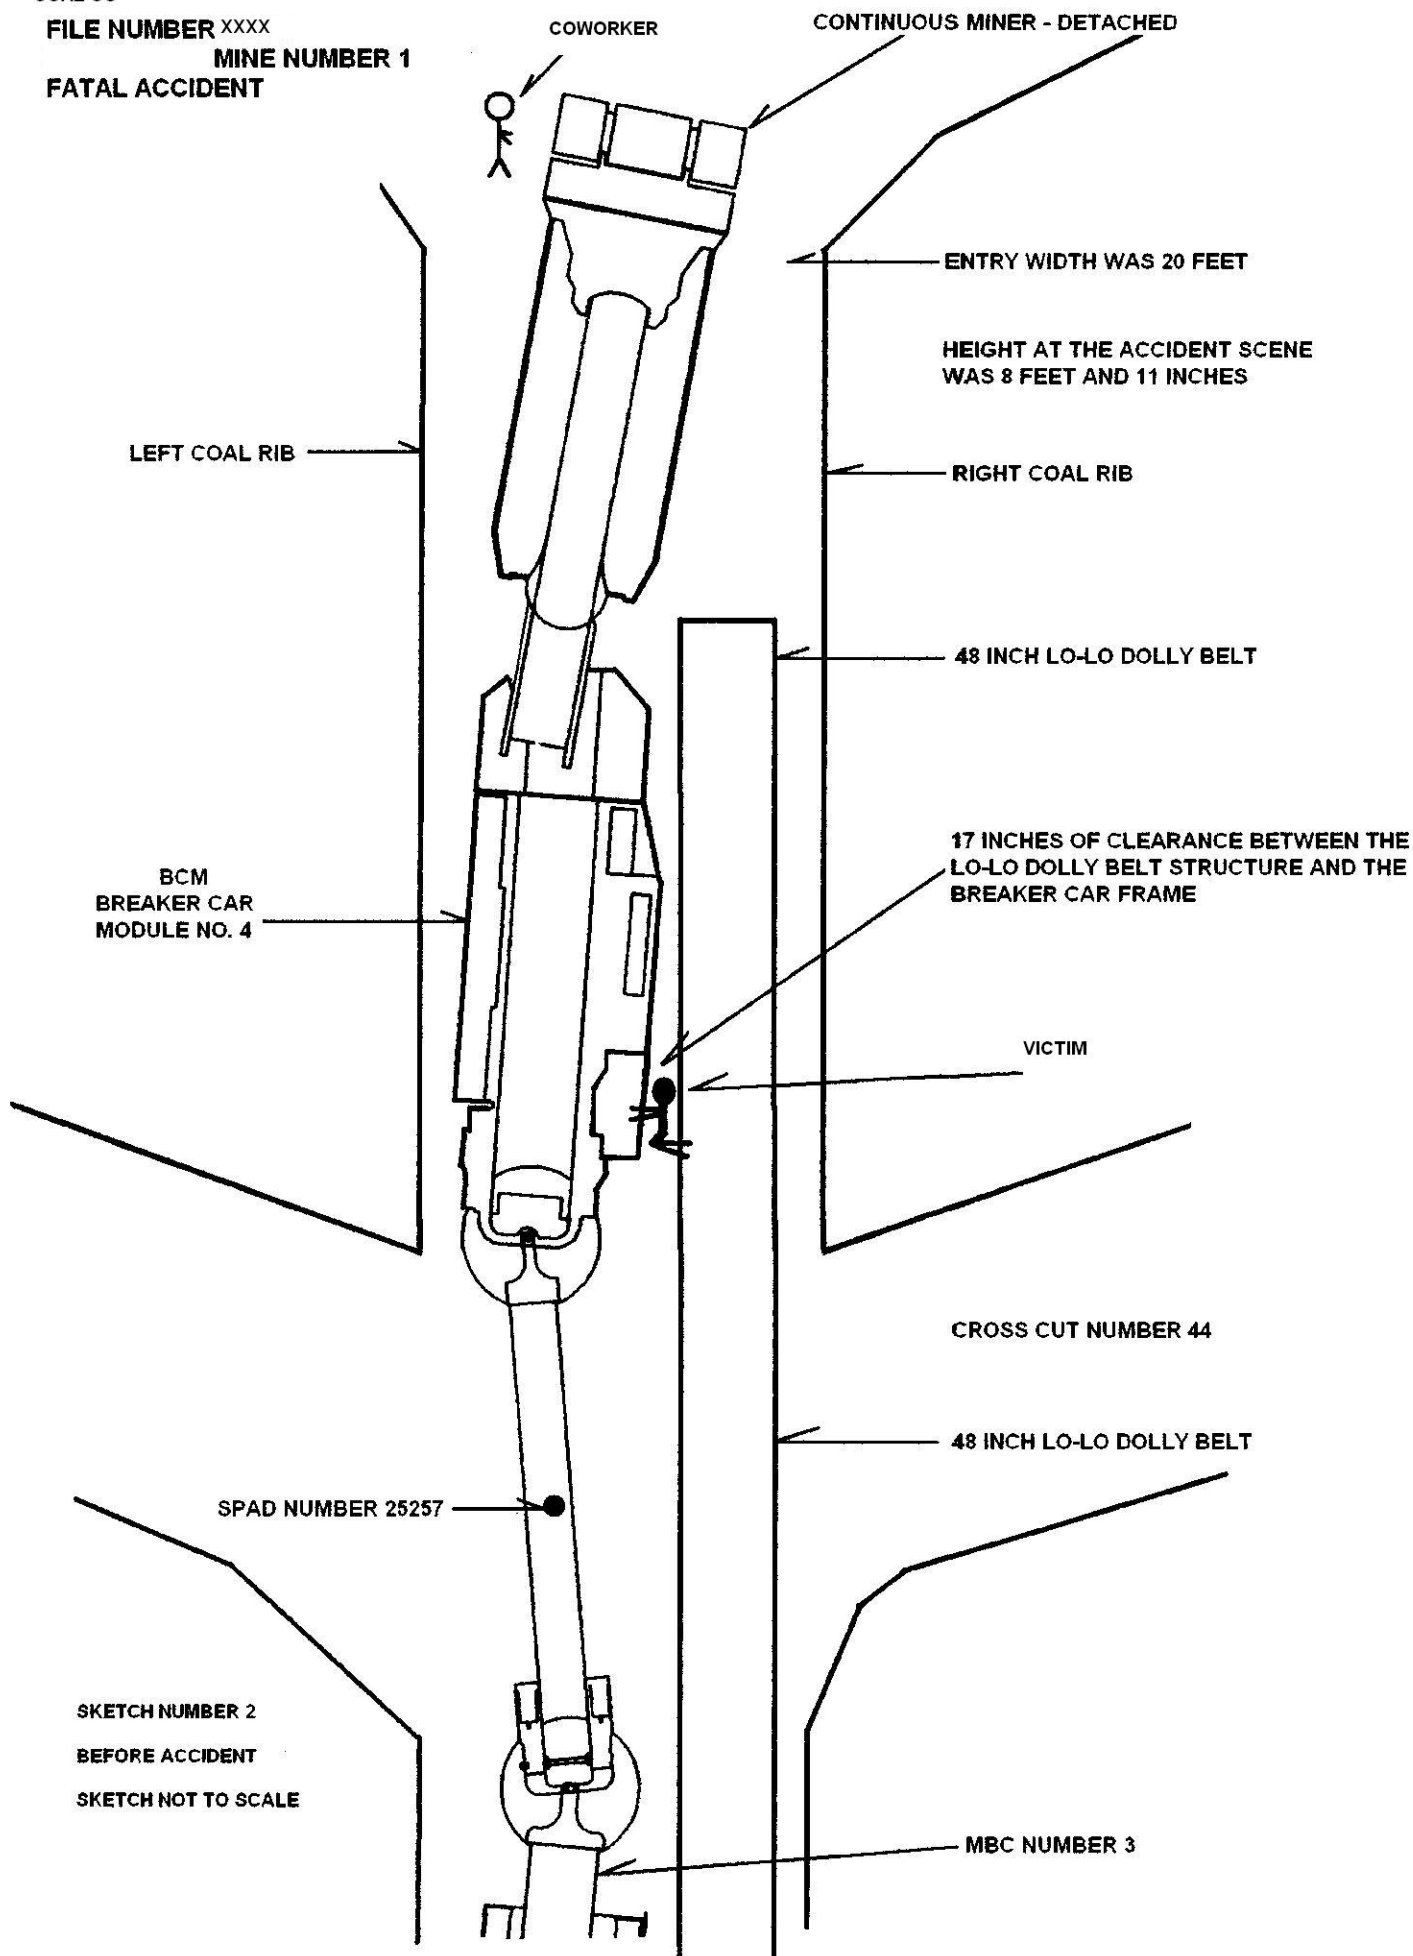
SKETCH NUMBER 2

BEFORE ACCIDENT

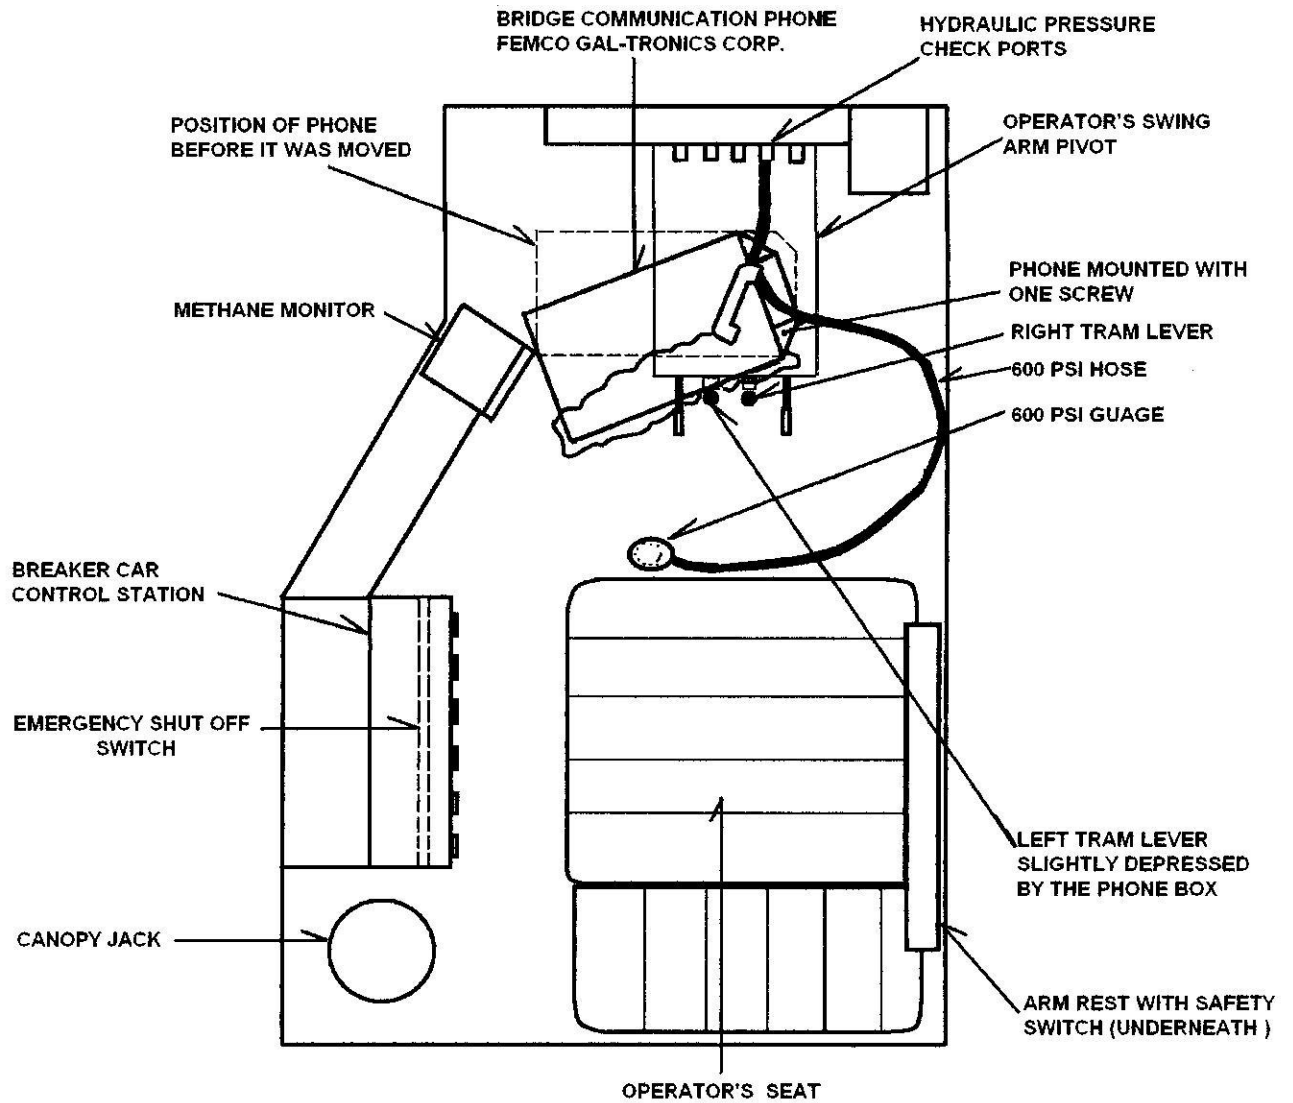
SKETCH NUMBER 4

OPERATORS COMPARTMENT AS
FOUND AFTER THE ACCIDENT
